**Flood Control Project Maintenance**  
**2013 Structure Summary Report**  
**Overall Unit and Item Ratings**

**Sacramento County**

**American River Pumping Plant No. 1 Howe Avenue Storm Drain D - 05**

**American River Pumping Plant No. 2 Willhaggin Storm Drain D - 43**

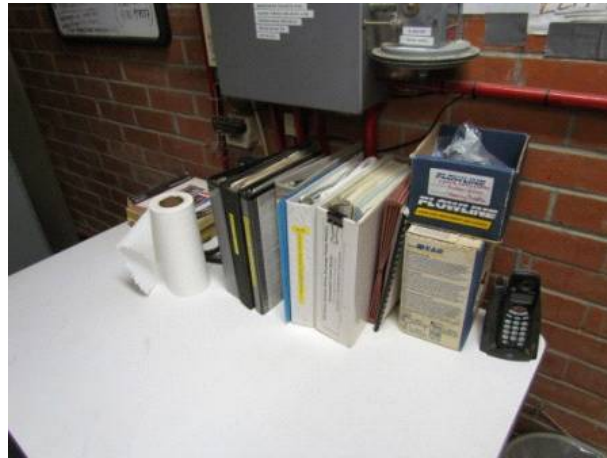
Levee Mile Report Line	1
Start Levee Mile	0.00
End Levee Mile	0.00
Location	
Category	Pump Stations
Item	Operating Log

Photo shows desk with maintenance log and O & M manuals on site 07/25/2012

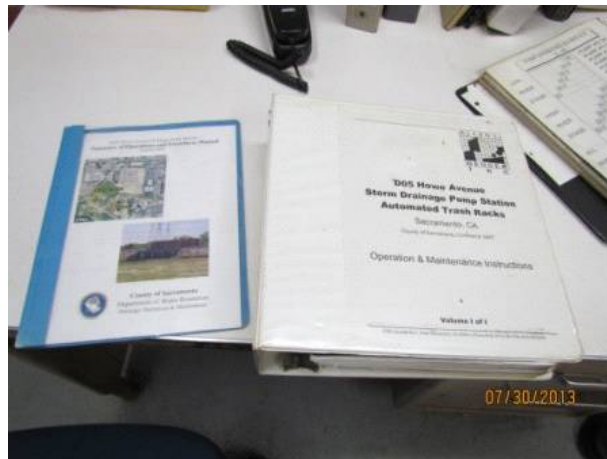
Levee Mile Report Line	2
Start Levee Mile	0.00
End Levee Mile	0.00
Location	
Category	Pump Stations
Item	Operation & Maintenance Manual

View of the O&M manual.

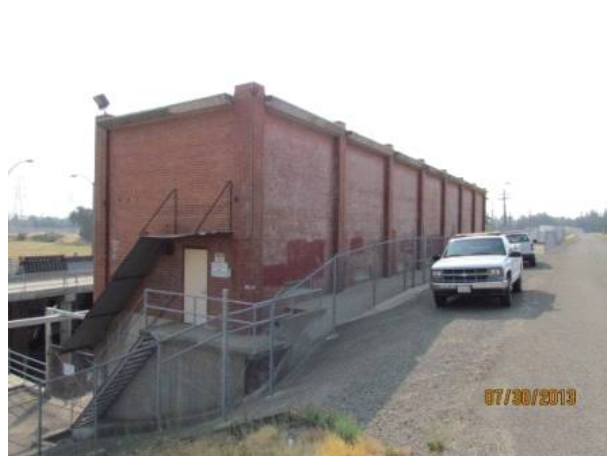
Levee Mile Report Line	3
Start Levee Mile	0.00
End Levee Mile	0.00
Location	
Category	Pump Stations
Item	Plant Building

View of the pump building.

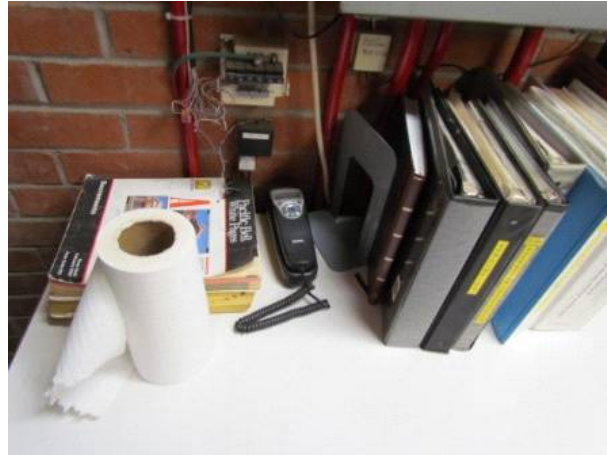
Levee Mile Report Line	4
Start Levee Mile	0.00
End Levee Mile	0.00
Location	
Category	Pump Stations
Item	Communications

View of the landline telephone on site 07/25/2012

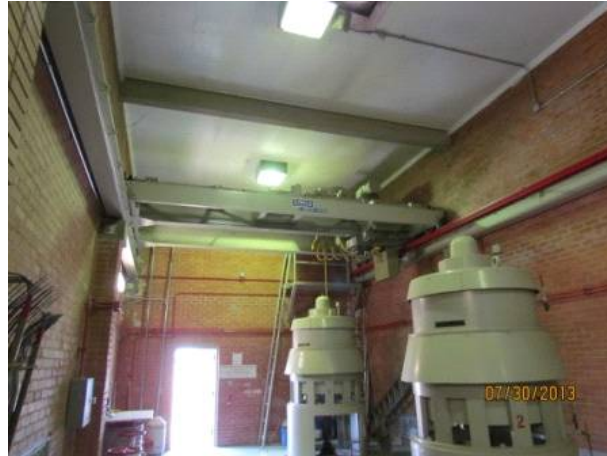
Levee Mile Report Line	6
Start Levee Mile	0.00
End Levee Mile	0.00
Location	
Category	Pump Stations
Item	Cranes

View of the cranes inside the building.

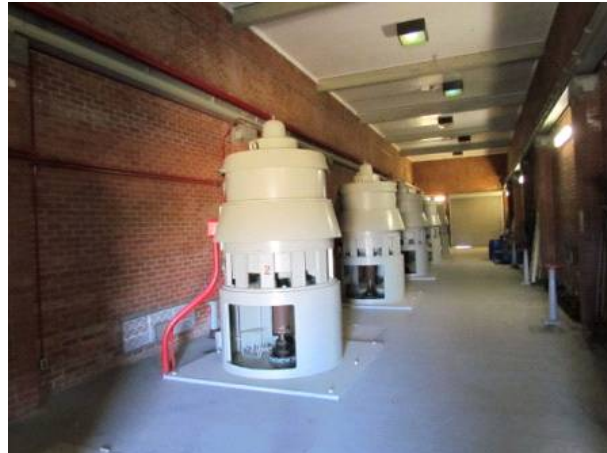
Levee Mile Report Line	7
Start Levee Mile	0.00
End Levee Mile	0.00
Location	
Category	Pump Stations
Item	Pumps

View of the pumps 07/25/2012

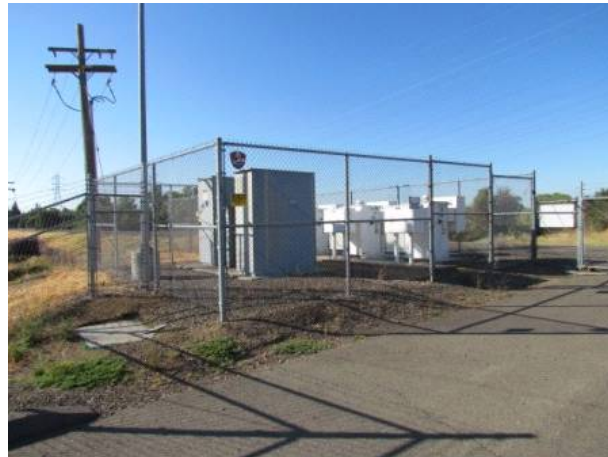
Levee Mile Report Line	8
Start Levee Mile	0.00
End Levee Mile	0.00
Location	
Category	Pump Stations
Item	Power

Photo shows security fencing, power source and backup generator located in the background  
07/25/2012

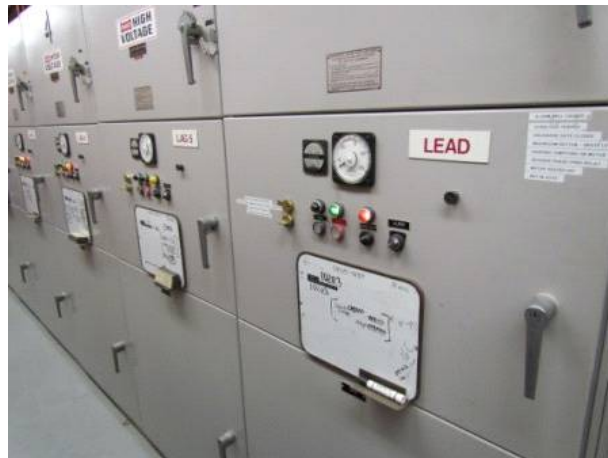
Levee Mile Report Line	10
Start Levee Mile	0.00
End Levee Mile	0.00
Location	
Category	Pump Stations
Item	Pump Control Systems

10	0.00	0.00	Pump Stations	Pump Control Systems		A	Item inspected visually only. Item was not operated during the inspection. Inspector Comments: These items appear to be operational and properly maintained.	38.584600 ° -121.421417 °	38.584600 ° -121.421417 °	11 Y
11	0.00	0.00	Pump Stations	Sumps/Wet Well		A	Inspector Comments: Sumps and wet wells are free of sediment and debris.	38.584600 ° -121.421417 °	38.584600 ° -121.421417 °	12 Y
12	0.00	0.00	Pump Stations	Trash Racks		A	Inspector Comments: Trash racks are in place, properly maintained and clear of any debris.	38.584600 ° -121.421417 °	38.584600 ° -121.421417 °	13 Y

View of the pump control panel 07/25/2012

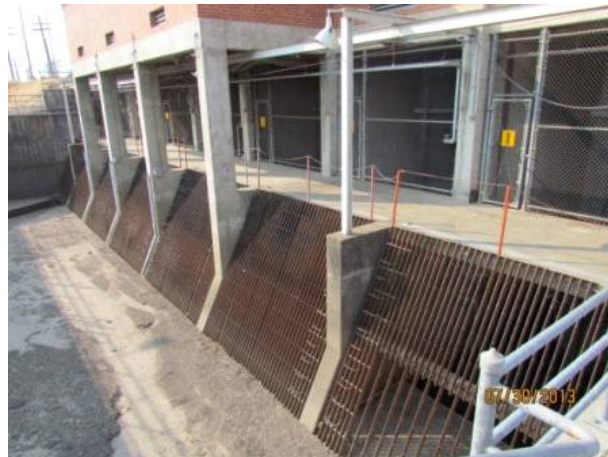
Levee Mile Report Line	11
Start Levee Mile	0.00
End Levee Mile	0.00
Location	
Category	Pump Stations
Item	Sumps/Wet Well

View of the sumps and wells protected by trash racks.

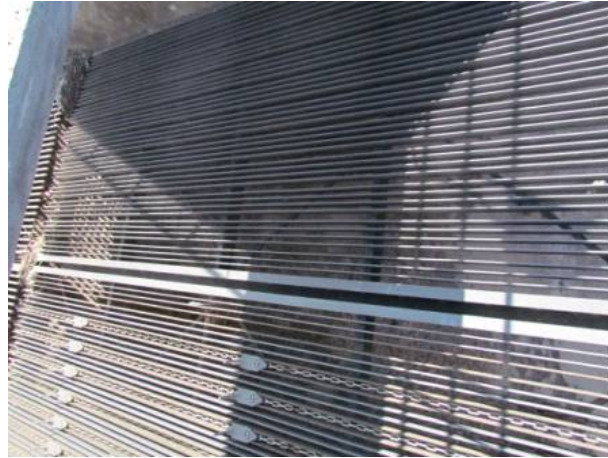
Levee Mile Report Line	12
Start Levee Mile	0.00
End Levee Mile	0.00
Location	
Category	Pump Stations
Item	Trash Racks

View of the trash racks and rakes 07/25/2012

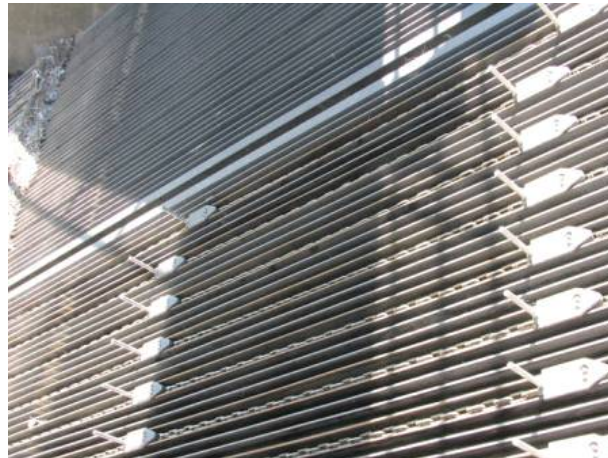
Levee Mile Report Line	13
Start Levee Mile	0.00
End Levee Mile	0.00
Location	
Category	Pump Stations
Item	Trash Rakes

08/05/2011 Close up photo of trash rake, note cleanliness and free of debris.

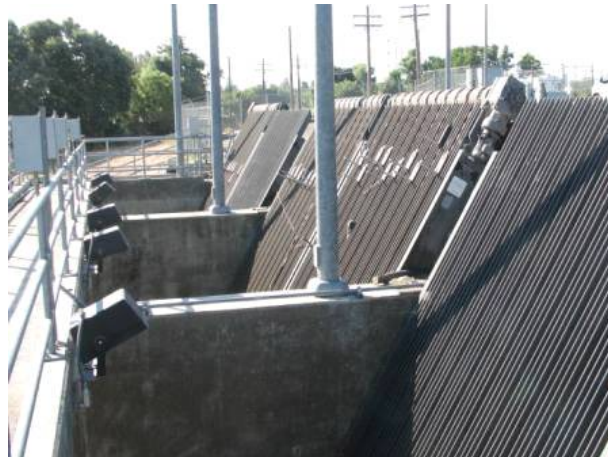
Levee Mile Report Line	13
Start Levee Mile	0.00
End Levee Mile	0.00
Location	
Category	Pump Stations
Item	Trash Rakes

08/05/2011 Extended photo of trash rakes.

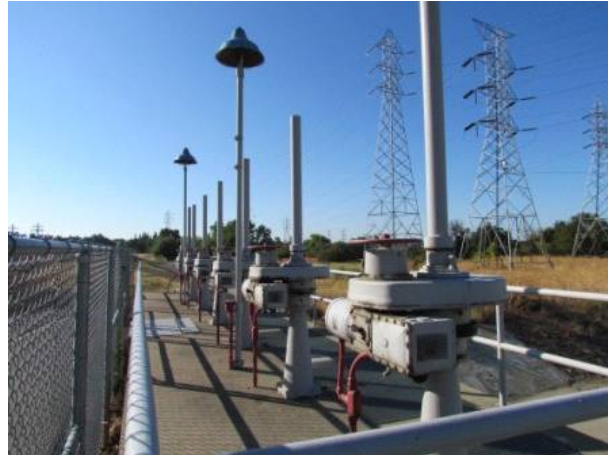
Levee Mile Report Line	15
Start Levee Mile	0.00
End Levee Mile	0.00
Location	
Category	Pump Stations
Item	Electric Gate Operators

View of the gate operators 07/25/2012

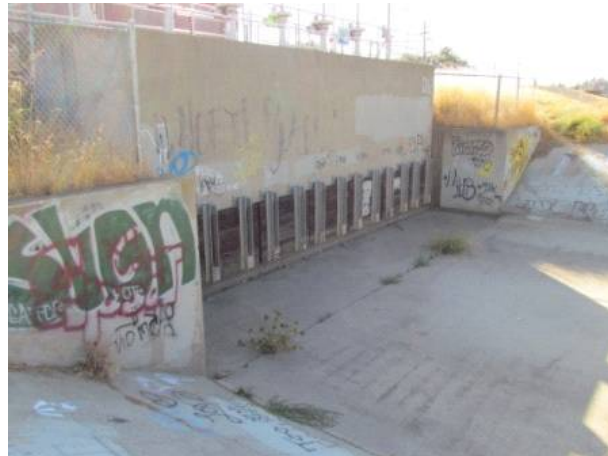
Levee Mile Report Line	18
Start Levee Mile	0.00
End Levee Mile	0.00
Location	
Category	Pump Stations
Item	Flap Gates

View of the flap gates on waterside 07/25/2012

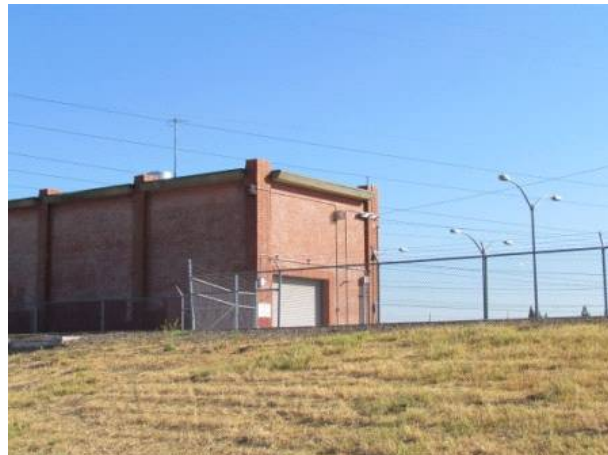
Levee Mile Report Line	20
Start Levee Mile	0.00
End Levee Mile	0.00
Location	
Category	Pump Stations
Item	Security Fencing

View of the security fencing around the pumping facility 07/25/2012

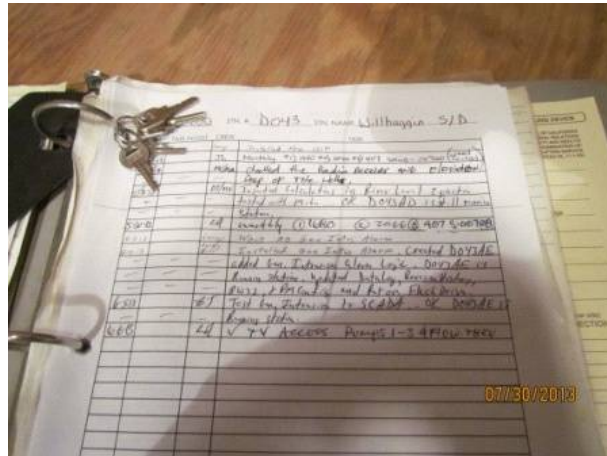
Levee Mile Report Line	1
Start Levee Mile	0.00
End Levee Mile	0.00
Location	
Category	Pump Stations
Item	Operating Log

Photo shows operating log on site.

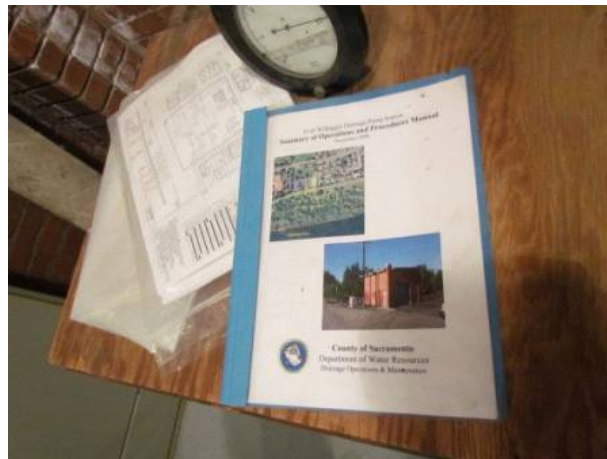
Levee Mile Report Line	2
Start Levee Mile	0.00
End Levee Mile	0.00
Location	
Category	Pump Stations
Item	Operation & Maintenance Manual

07/25/2012 Photo shows O&M manual on site.

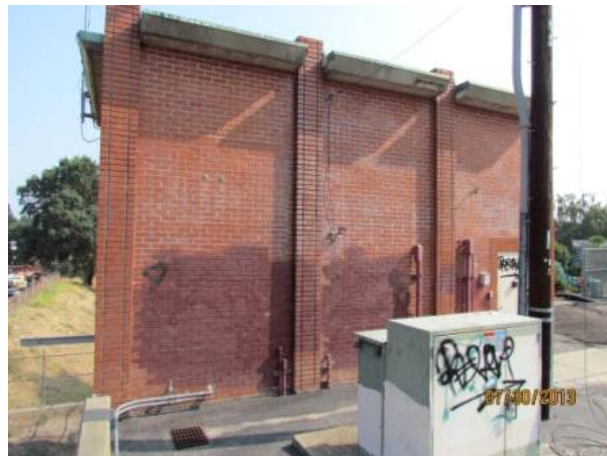
Levee Mile Report Line	3
Start Levee Mile	0.00
End Levee Mile	0.00
Location	
Category	Pump Stations
Item	Plant Building

View of the pumping plant.

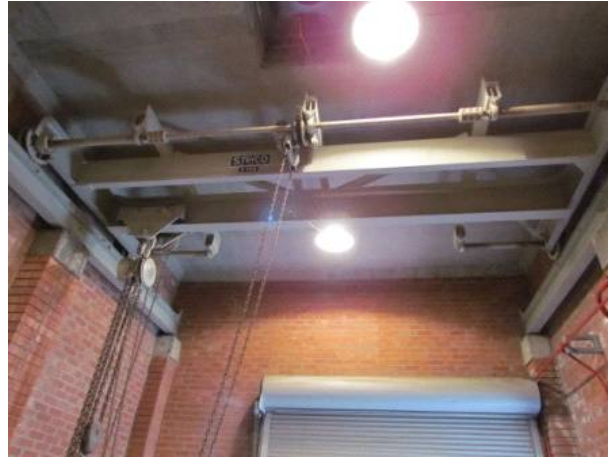
Levee Mile Report Line	6
Start Levee Mile	0.00
End Levee Mile	0.00
Location	
Category	Pump Stations
Item	Cranes
View of the crane above the pumps inside the building. 07/25/2012	
mkhashch_t_20130730_019.JPG

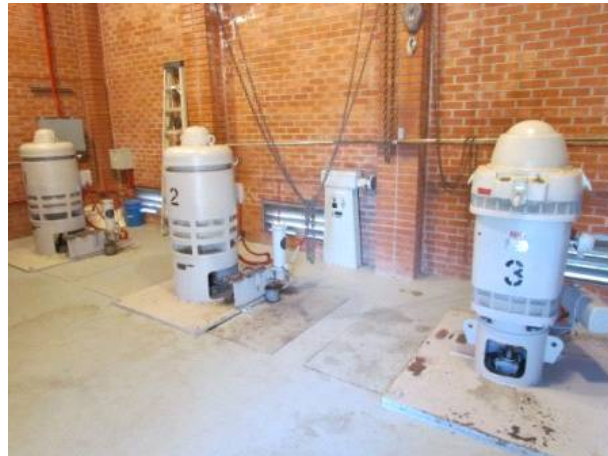
Levee Mile Report Line	7
Start Levee Mile	0.00
End Levee Mile	0.00
Location	
Category	Pump Stations
Item	Pumps
View of the pump motors 07/25/2012	
mkhashch_t_20130730_020.JPG

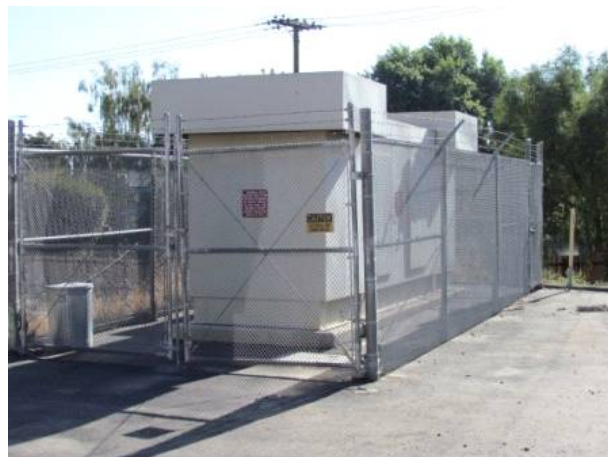
Levee Mile Report Line	8
Start Levee Mile	0.00
End Levee Mile	0.00
Location	
Category	Pump Stations
Item	Power
View of the backup generator 07/25/2012	
mkhashch_t_20130730_021.JPG

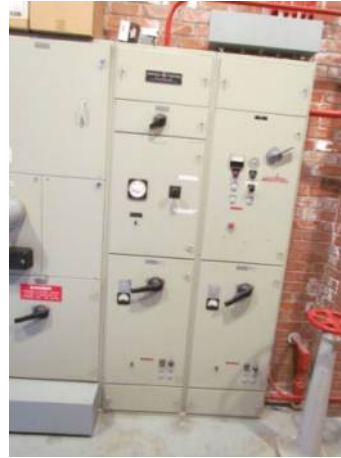
Levee Mile Report Line	10
Start Levee Mile	0.00
End Levee Mile	0.00
Location	
Category	Pump Stations
Item	Pump Control Systems

10	0.00	0.00	Pump Stations	Pump Control Systems		A	Item inspected visually only. Item was not operated during the inspection. Inspector Comments: Controls appear well maintained and free of corrosion.	38.584904 ° -121.421534 °	38.584904 ° -121.421534 °	11 Y	
11	0.00	0.00	Pump Stations	Sumps/Wet Well		A	Inspector Comments: Wet well is clear of debris.	38.584904 ° -121.421534 °	38.584904 ° -121.421534 °	12 Y	
12	0.00	0.00	Pump Stations	Trash Racks		A	Inspector Comments: Trash rack is in place and free of debris.	38.584904 ° -121.421534 °	38.584904 ° -121.421534 °	13 Y	
13	0.00	0.00	Pump Stations	Trash Rakes		N	Inspector Comments: There is no mechanical trash rake at this facility.	38.584904 ° -121.421534 °	38.584904 ° -121.421534 °	14 Y

View of the pump controls panel 07/25/2012

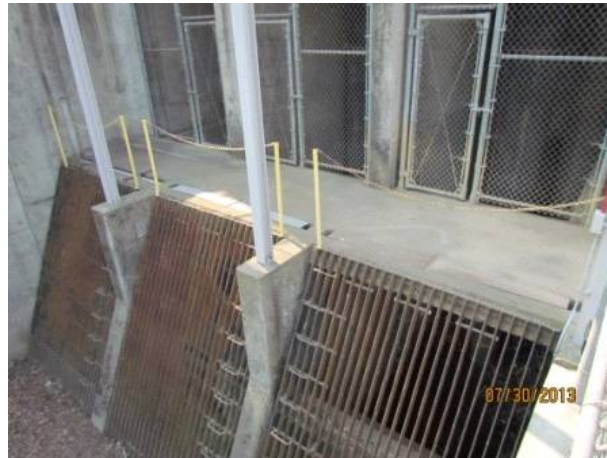
Levee Mile Report Line	12
Start Levee Mile	0.00
End Levee Mile	0.00
Location	
Category	Pump Stations
Item	Trash Racks

Photo shows properly maintained trash rack free of debris.

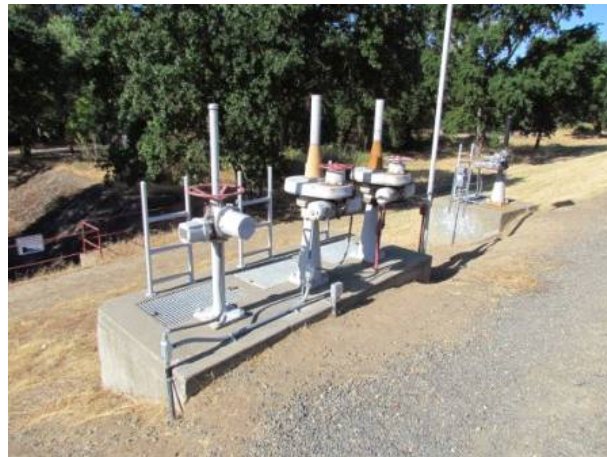
Levee Mile Report Line	15
Start Levee Mile	0.00
End Levee Mile	0.00
Location	
Category	Pump Stations
Item	Electric Gate Operators

View of the gate controls 07/25/2012

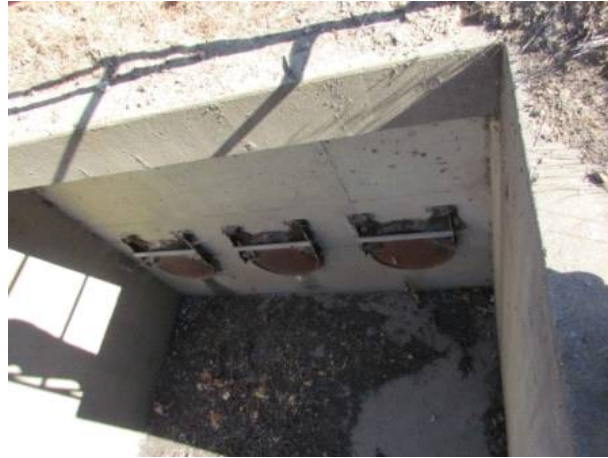
Levee Mile Report Line	18
Start Levee Mile	0.00
End Levee Mile	0.00
Location	
Category	Pump Stations
Item	Flap Gates
View of the flap gates 07/25/2012	
mkhashch_t_20130730_025.JPG
